# Manhole Inspection Summary

Manhole # S35SS1007MH

Insp Date: **2/8/07 10:24 AM**

**Location** Address: **5116 NORWOOD RD**

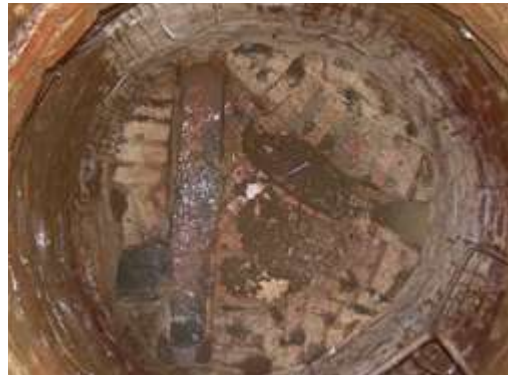
Top View

Bench and Channel debris.

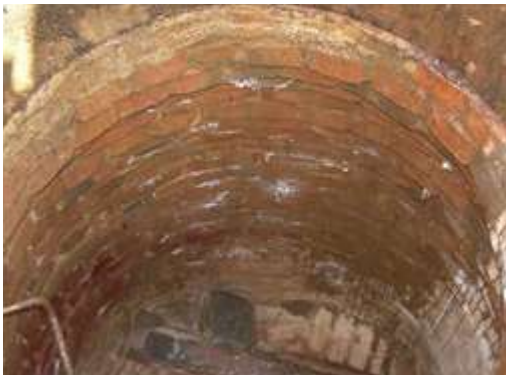
Defect

Frame leaks. Adjustment deterioration and infiltration. Corbel and Barrel infiltration.

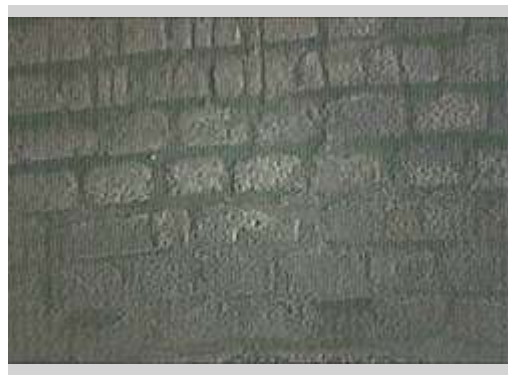
Defect

Barrel deterioration and infiltration.

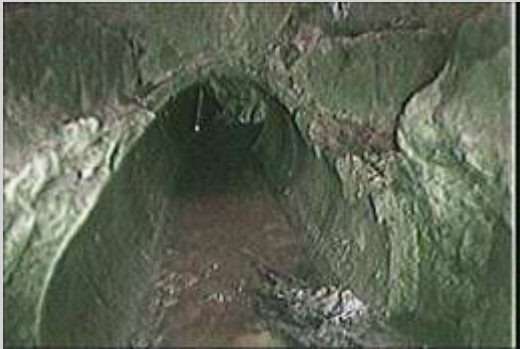
### 8 in. Circular Gravity Sewer Pipe Out @ 12 O'Clock

Infiltration: **Evidence** Pipe Seal Cond: **Cracked**

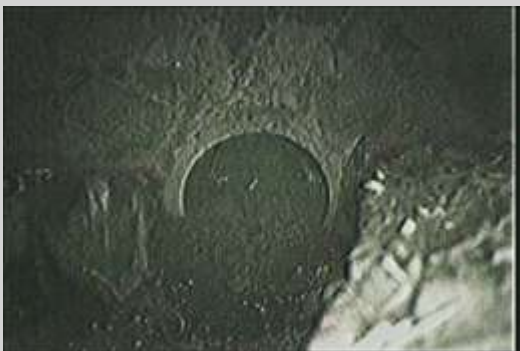
### 6 in. Circular Gravity Sewer Pipe In @ 4 O'Clock

Deposits: ☐ None ☒ **Mud** ☐ Sludge ☒ **Debris** ☐ Grease

Silt Depth: **4** (in.) Deposits Extent: **Heavy**

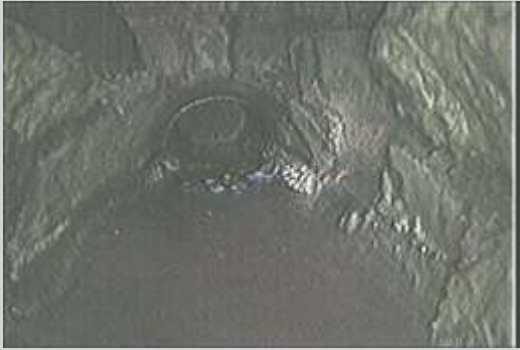
### Pipe In @ 6 O'Clock

Plugged.

Pipe Material: ☐ Pipe Lined  
Invert Depth: (ft.) Flow Characteristics: **None**  
Deposits: ☒ None ☐ **Mud** ☐ Sludge ☐ **Debris** ☐ Grease  
Silt Depth: (in.) Deposits Extent:  
Infiltration: **Evidence** Pipe Seal Cond: **Unknown**

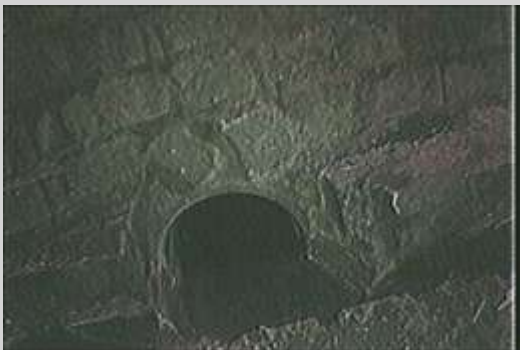
#### Pipe In @ 9 O'Clock

Pipe Material: **Clay** ☐ Pipe Lined  
Invert Depth: **7.69** (ft.) Flow Characteristics: **Slow**  
Deposits: ☐ None ☒ **Mud** ☐ Sludge ☒ **Debris** ☐ Grease  
Silt Depth: **0.5** (in.) Deposits Extent: **Light**  
Infiltration: **None** Pipe Seal Cond: **Unknown**
